TWO STROKE

SUZUKI

Service Bulletin Index

SUZUKI SERVICE BULLETIN

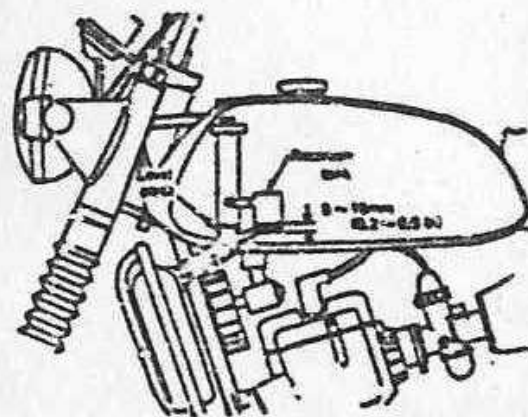
Cooling solution level

Cooling System Capacity: The specified cooling system capacity is 4.5 liters or 4.75 U. S. quarts. The cooling mixture should be maintained 5-15mm from the bottom of the radiator reservoir tank. To facilitate daily inspection of this level, a white level plate is located inside the radiator refill pipe. The cooling solution should be maintained near this plate at all times. A daily inspection should be made of the cooling mixture level before starting the engine.

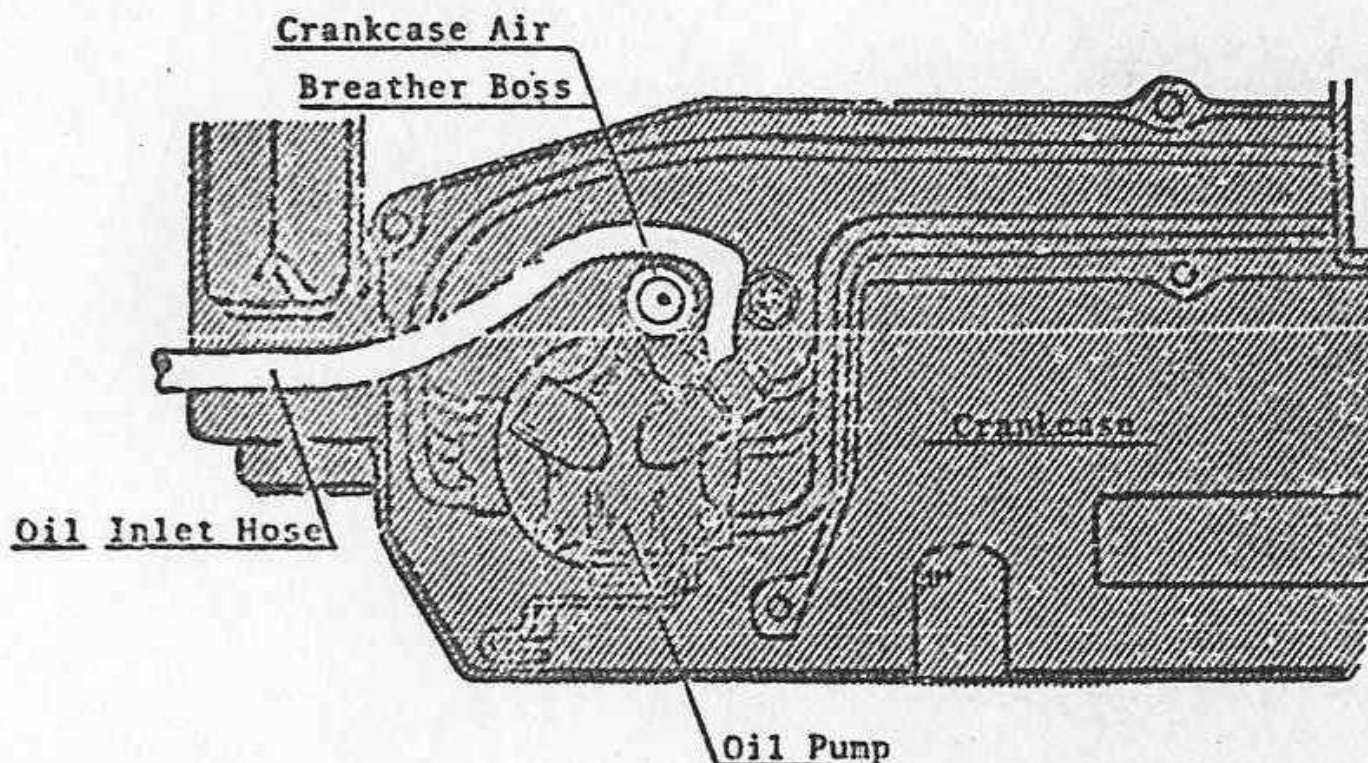
If care is not taken it is possible to pinch the inlet line from the oil tank to the oil pump when installing the oil pump cover. Pinching this line closed will result in no oil getting to the oil pump, or to the engine. Naturally this can cause a multitude of problems due to lack of lubrication.

1. Take special care that the oil pump inlet hose is routed around the crankcase air breather boss before installing the oil pump cover.
2. Before tightening down the screws holding the cover, check that the cover seats flush against the crankcase, without any gaps. If there is a gap, this would indicate that the hose might be pinched between the breather boss and the cover.
3. After tightening the screws, start the engine and check at the lines for any evidence of oil starving.

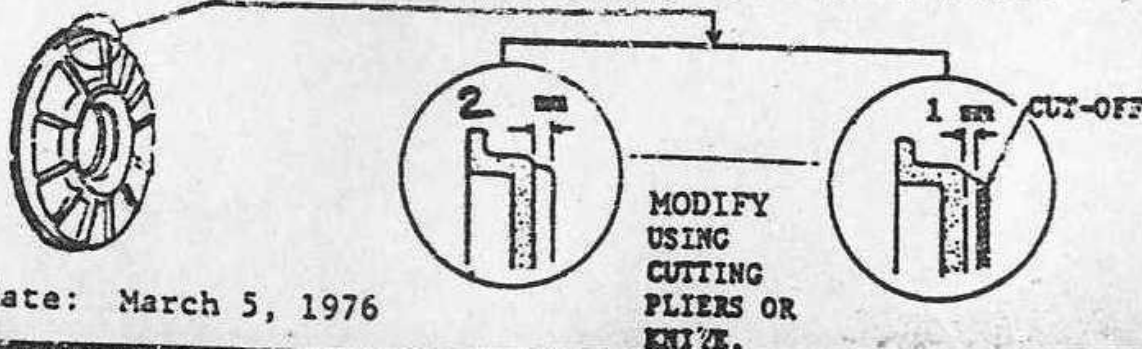
On future parts orders only the new type starter clutch parts will be supplied. However, the old type LH crankshaft oil seal will still be supplied until such time as the existing stock is exhausted. Therefore, when the old oil seal is retained in the unit and the starter clutch is modified or replaced, it is necessary to check the rib height of the oil seal and modify the same as shown.

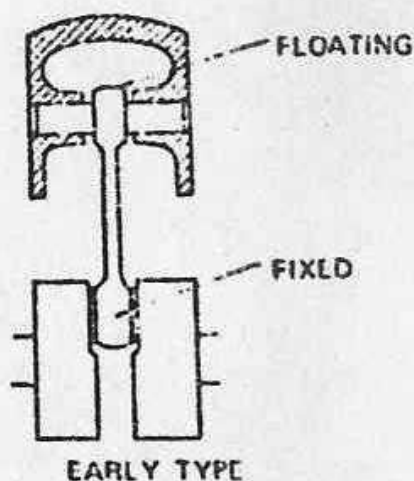
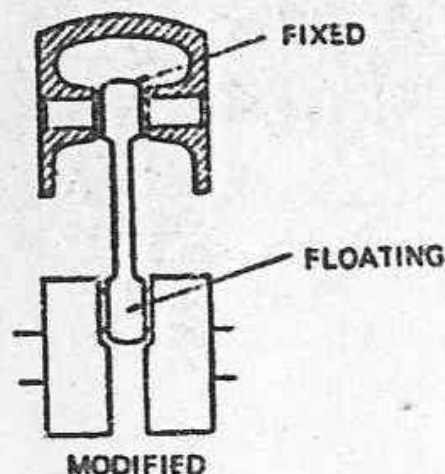
Side movement of the connecting rod is restricted on the small end, and the big end has been changed to a floating type as shown in the illustration below.

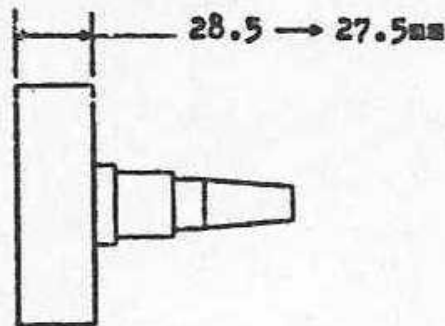
The width of the crank wheels has been reduced from 28.5mm to 27.5mm.

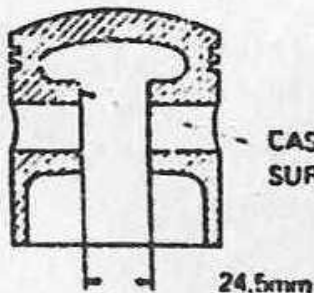
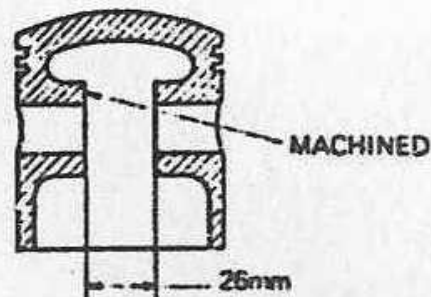
The pistons inside surface has been changed from a casting surface to that of a machined surface. The inside dimension between the wrist pin bosses has also been changed.

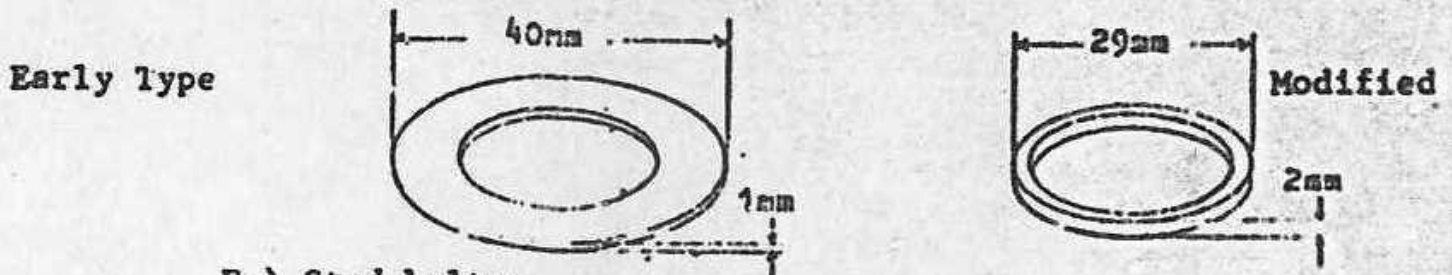
- D.) Thrust washer, crank pin bearing:
In order to have the connecting rod floating on the crank pin, this thrust washer has been modified as shown below.

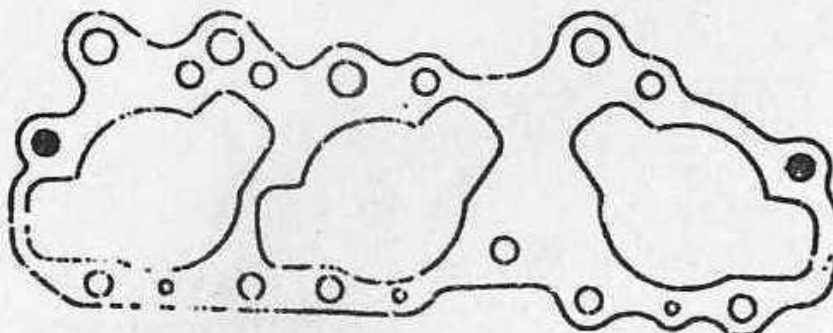
● : ENLARGED

- F.) Cylinder gasket:
Two holes in the gasket have been enlarged from 11mm to 12.5mm in diameter to match the new type stud bolts.

The above crankshaft set does not include the cylinder base gasket, although it has been modified as explained in paragraph #2 (F). Consequently, when using the old style gasket, the necessary two holes should be enlarged before assembly.

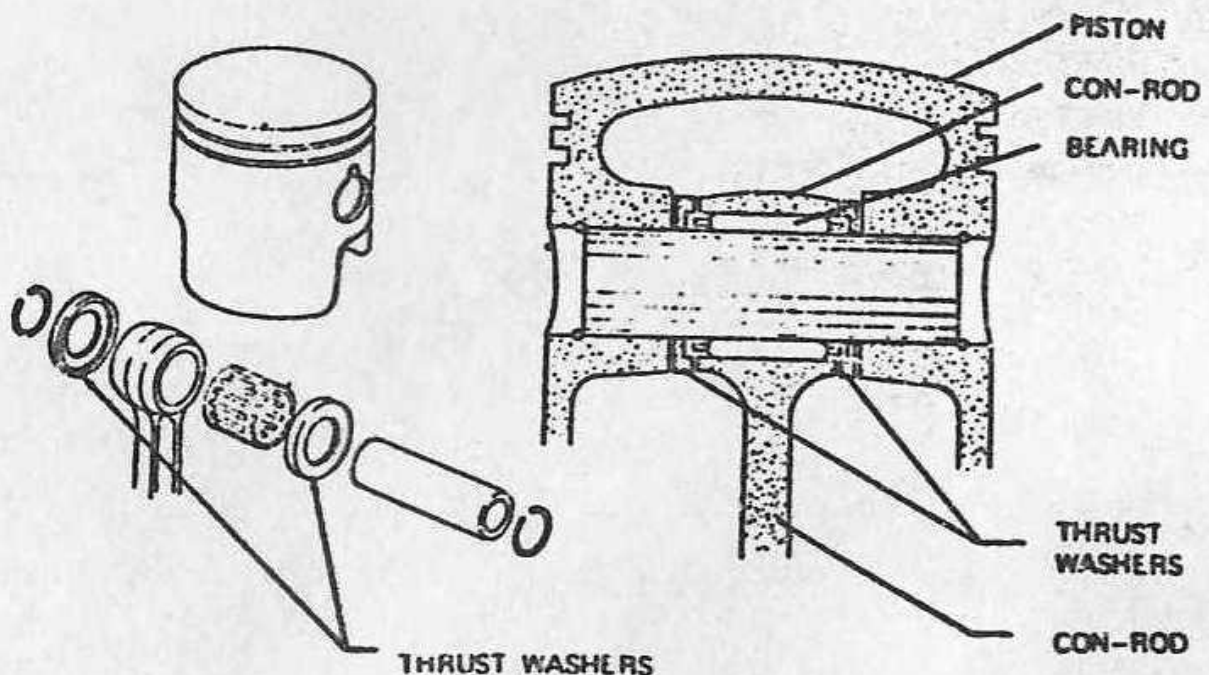
- 1) The pistons and thrust washers should be assembled as shown below.

NOTE: Two different pistons are used in the GT750 engine, and they are marked "R" and "L" on top of the piston crown. The "R" piston is for the right cylinder and the "L" pistons are for the left and middle cylinders.

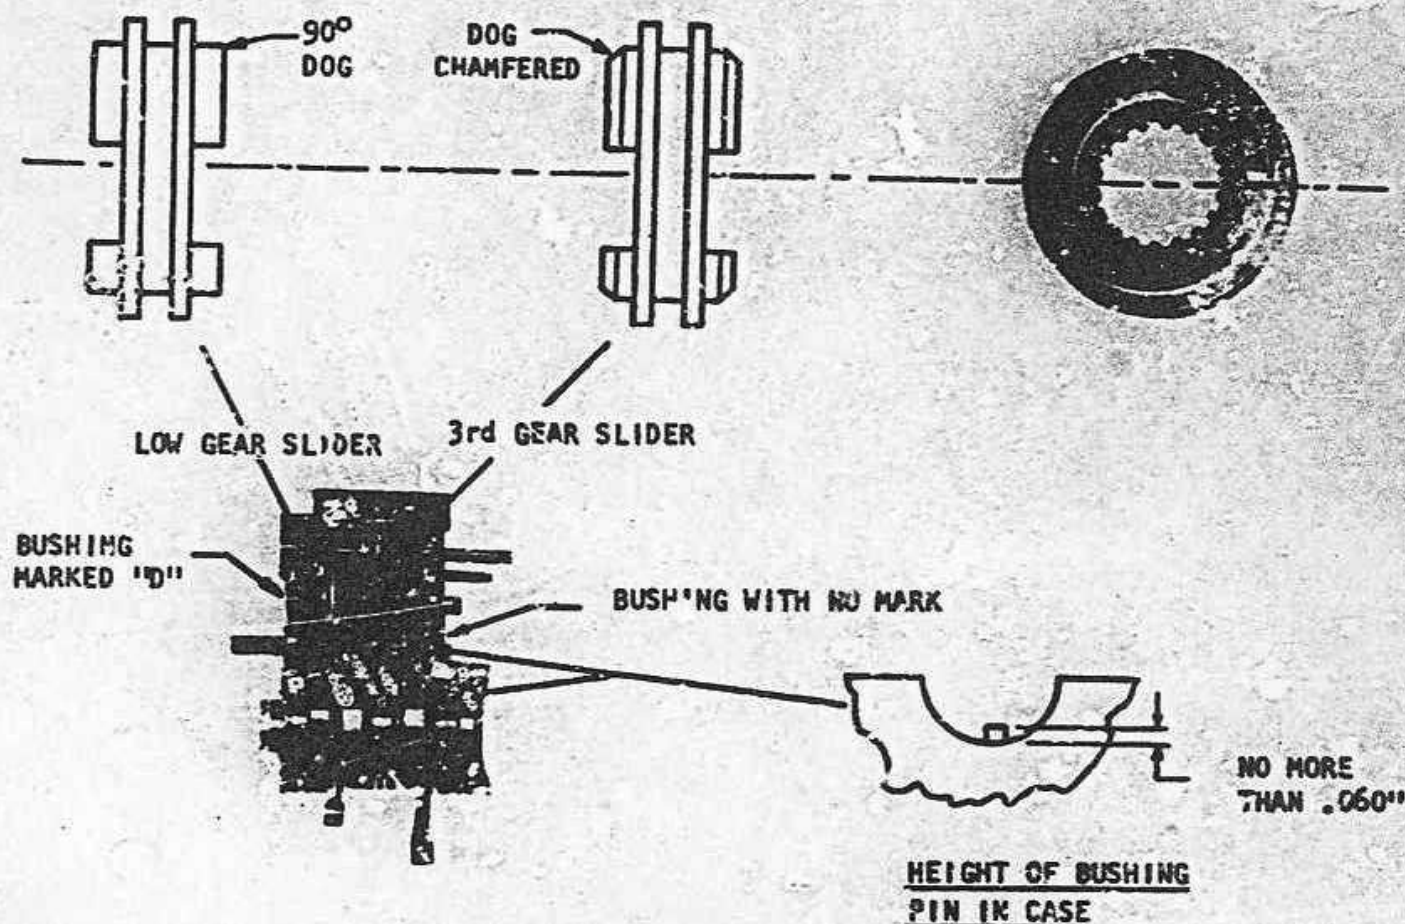
- A. Do not interchange low gear slider wheel with 3rd gear slider wheel. If the transmission is assembled this way, the bike will jump out of first gear under any load. The difference between the two wheels is shown below:

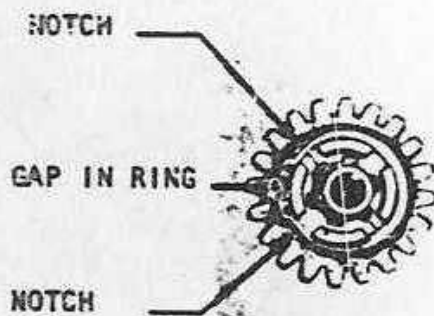
RIGHT
RING GAP CENTERED
BETWEEN GEAR NOTCHES

GAP IN RING
NOTCH
IN GEAR

WRONG
GEAR LOCATING RING
TABS CAN POP OUT

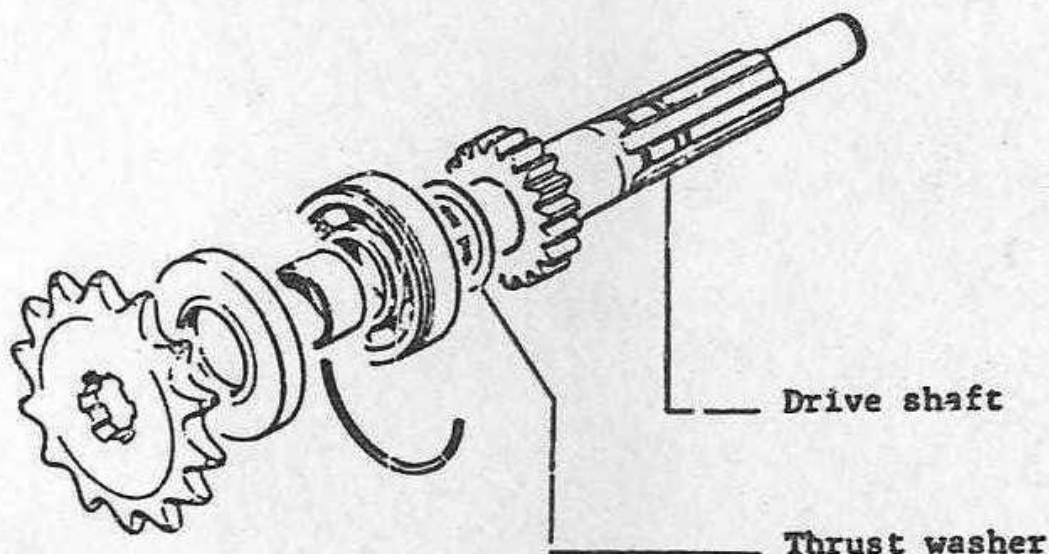
Top gear, driven, on the subject models has been increased in thickness and strength.

When using the new style driveshaft #24131-18002 with old style crankcases, the thrust washer #08211-22341 must be eliminated.

In the event that new cases are fitted and the old driveshaft re-used, washer #08211-22341 must be retained.

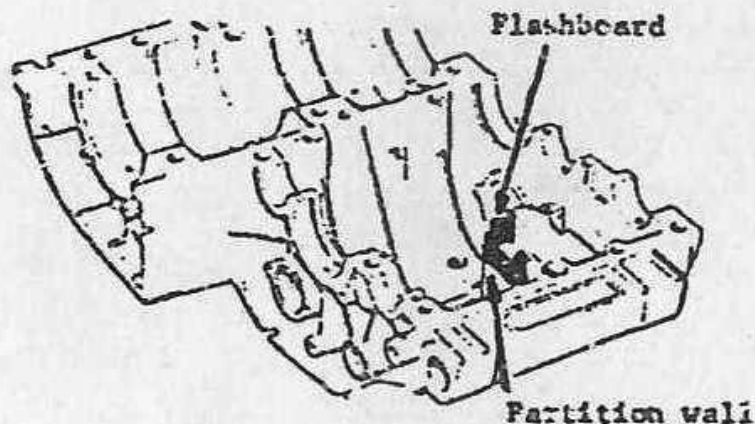
A rubber flashboard applied to the primary oil transfer chamber in the lower crankcase half is used to accommodate the increased oil capacity. The flashboard keeps the additional oil from entering the primary case, and therefore protects the clutch from excessive drag.

The flashboard in position is illustrated below.

The rubber flashboard is now available from the U. S. Suzuki Parts Department for T500's prior to the 1974 "L" model. Its application is strongly recommended whenever the crankcases are disassembled.

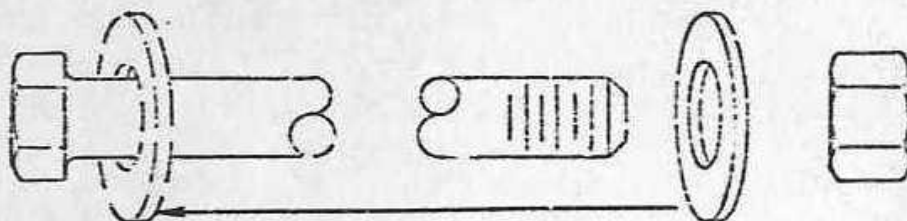
The shoulder radius of the T500 swing arm pivot shaft has been increased from 0.5mm to 1.0mm.

To accept the new type pivot shaft, the frame boss chamfer has also been increased 0.5mm.

NOTE: Should it be necessary to install a new type pivot shaft through an old type frame boss, simply move the washer from the nut side to the head side of the swing arm pivot shaft. The washer will conform to the shoulder radius of the pivot shaft.

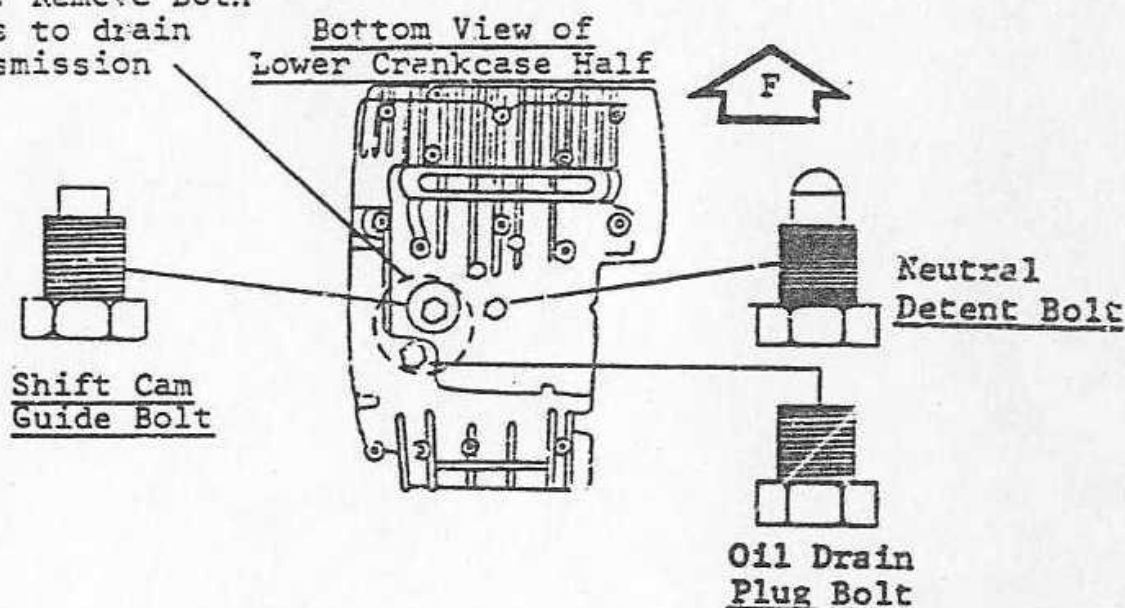
We have received occasional reports of T500 transmission failure immediately after an engine or transmission overhaul. Upon disassembling and inspecting the transmission, two situations have been found. The first reason a transmission would fail was that an oil drain plug bolt from another model Suzuki (Example TS185/250) had been interchanged with the shift cam guide bolt during the overhaul. The second reason for the transmission failure was due to a magnetic oil drain plug that had been substituted instead of the shift cam guide bolt.

Note: Remove both bolts to drain transmission oil.

In both situations the bolt did not extend into the locating groove of the shift cam drum far enough to restrict the shift drum from sliding from side to side in the crankcases. When this happens the shifting forks slide with the shift cam, allowing two sets of gears to become engaged at the time. This results in severe damage to the gears, and requires their replacement.

Therefore, whenever a T500 is overhauled, or the transmission oil changed by your service department, the final inspection after reassembly should be the proper placement of the shift cam guide bolt.
