TWO STROKE

SUZUKI

Service Bulletin Index

SUZUKI SERVICE BULLETIN

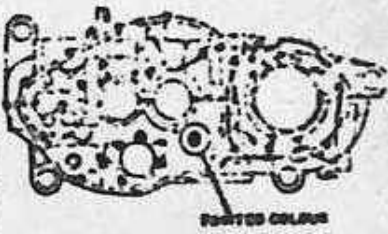
CRANKCASE COLOUR	1ST DRIVEN GEAR	2ND DRIVEN GEAR	KICK START DRIVE GEAR
BROWN	YELLOW	YELLOW	BROWN
BLACK			
RED			
YELLOW			
BLUE	WHITE	WHITE	YELLOW
GREEN			
WHITE

- a. The crankcase assembly is supplied with the 1st driven, 2nd driven and kick starter drive gears with which the optimum backlash is obtained. Therefore, install these gears when replacing the crankcase assembly.
- *b. Second drive gear is not supplied with the crankcase assembly, but for engines prior to number GT750-73059 it must be replaced in conjunction with second driven gear which is supplied with the crankcase assembly.
